# PLAY AREA SAFETY INSPECTION REPORT

For Deopham and Hackford PC

On 11<sup>th</sup> March 2025

Play Area, Vicarage Road, Deopham

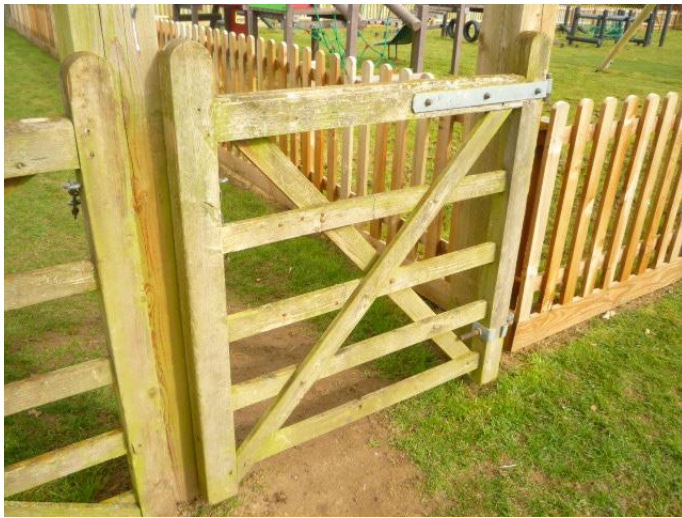
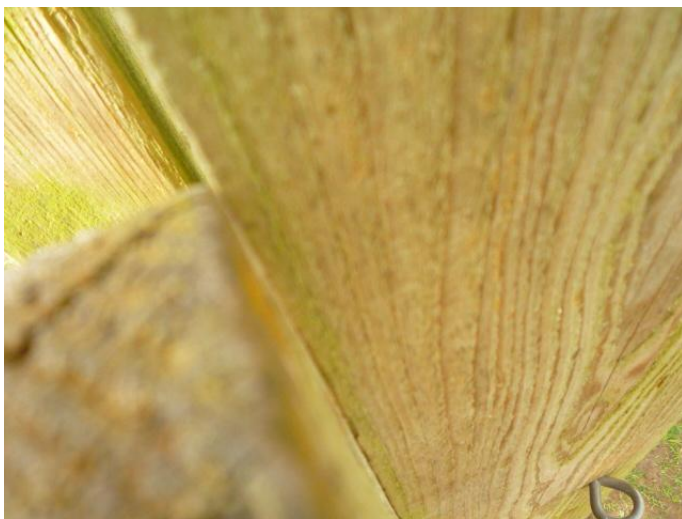
Field Pedestrian Gate x 1 - Crushing and Shearing Points on the side(s) of gate. Recommend to adjust gate/fit new rubber buffer to ensure a spacing of at least 12mm throughout the range of the gate to remove the hazard. The 12mm gap should also apply on the hinge side of the gate – Low to Medium risk.

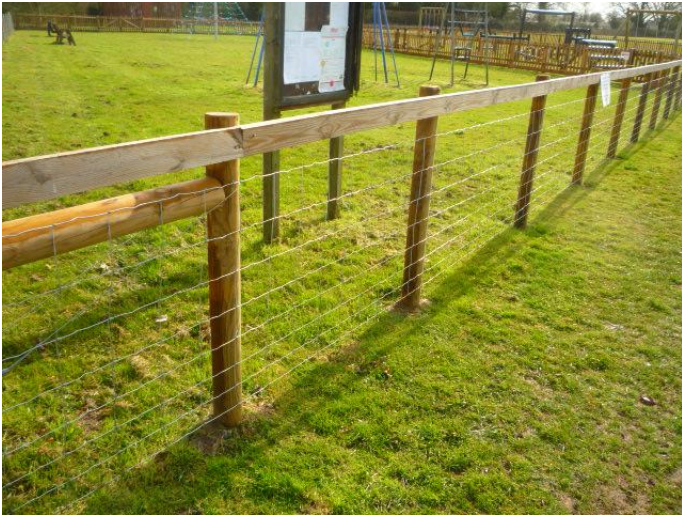
Fence – Stock fences that can be climbed are not recommended for play areas, however due to the rural location and the large amount of fencing, it should be accepted and only monitor – Low risk.

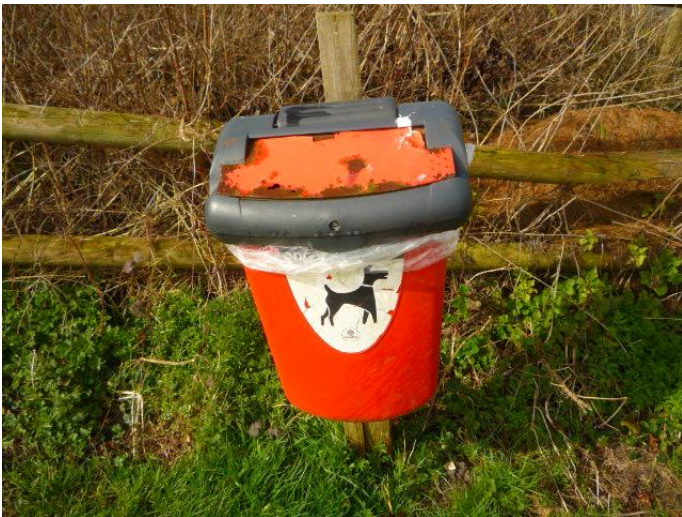
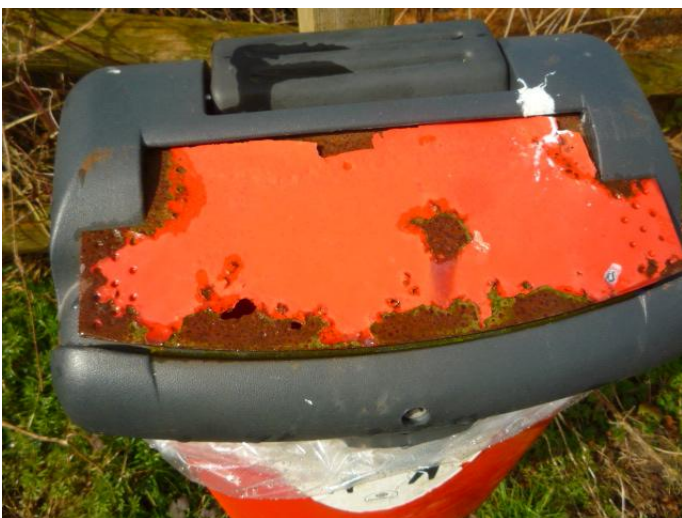
Dog Bin x 1- Recommend replace rusted top – Low risk.

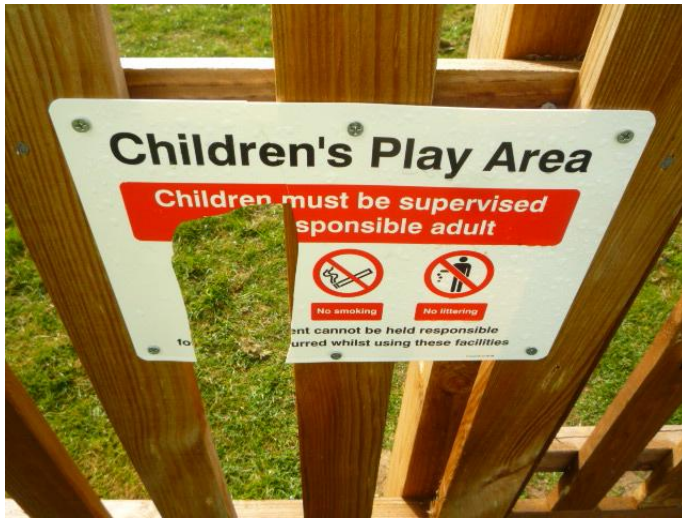
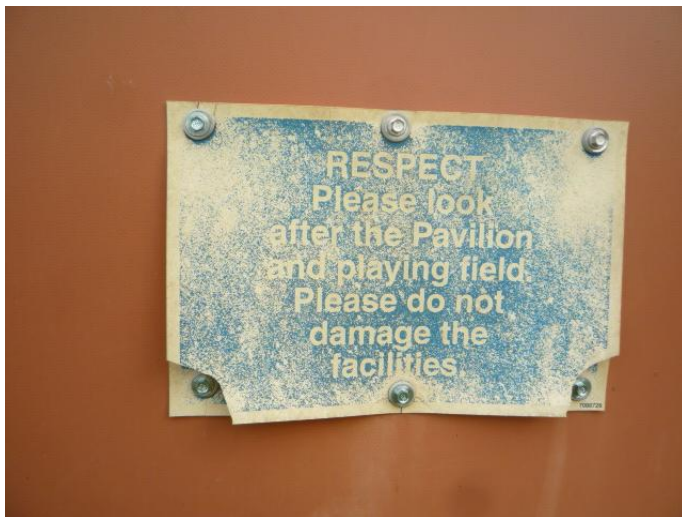
Recommend replace damaged signs – Low risk.

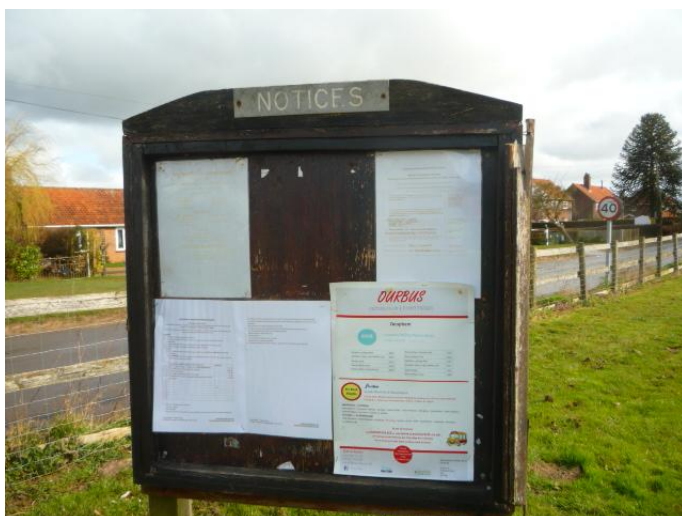
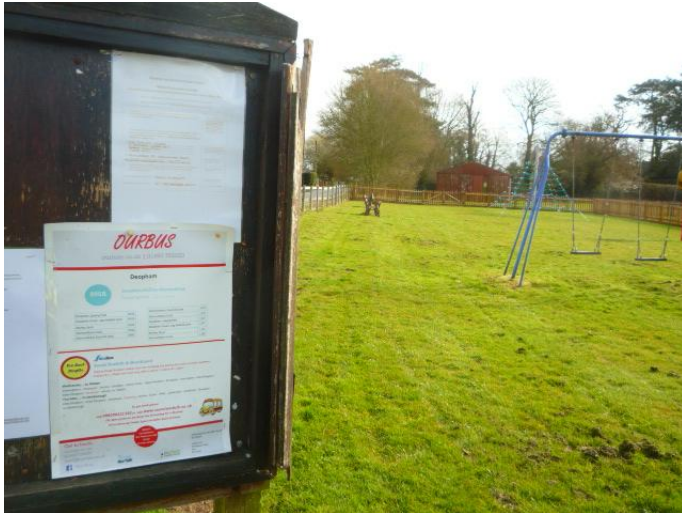
Notice Board – Recommend replace/repair damaged timber - Low risk.

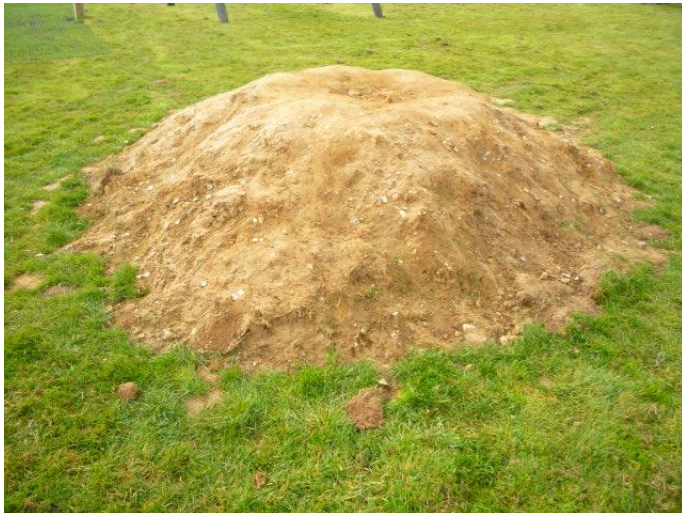
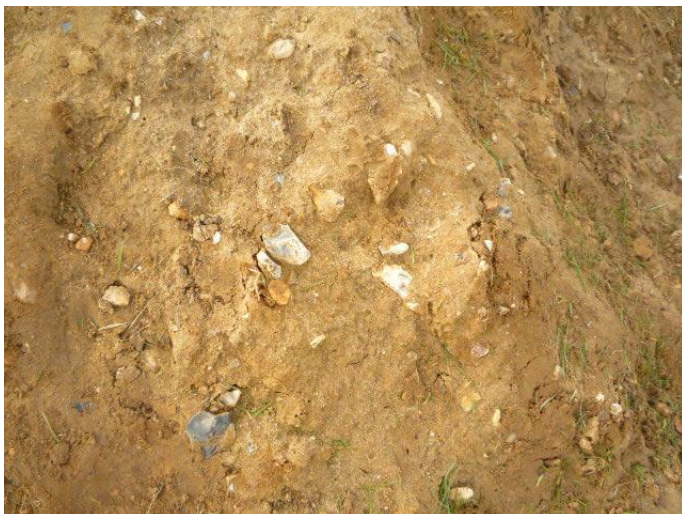
Soil Mound – Recommend remove stones, which are sharp and also are finding their way onto the grass areas - Low to Medium risk.

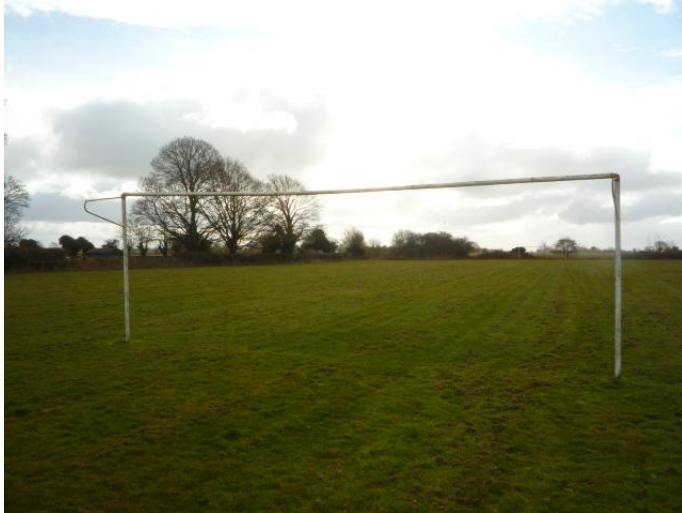
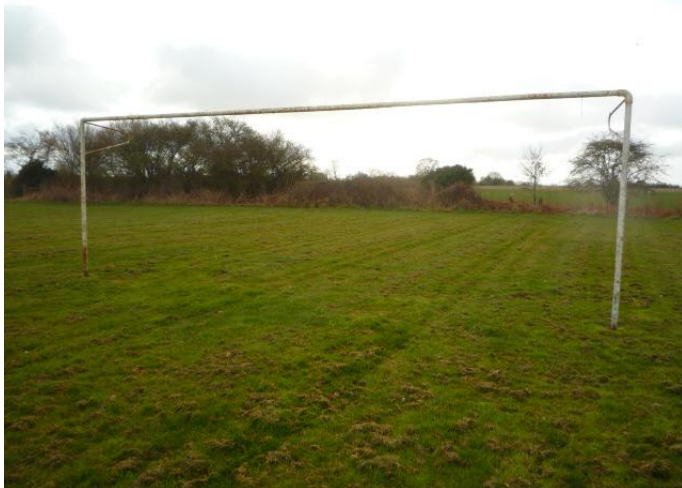
### **Item: Informal Football Goals x 2**

The item meets the requirements of EN1176 where this may be tested on site without dismantling or destruction.

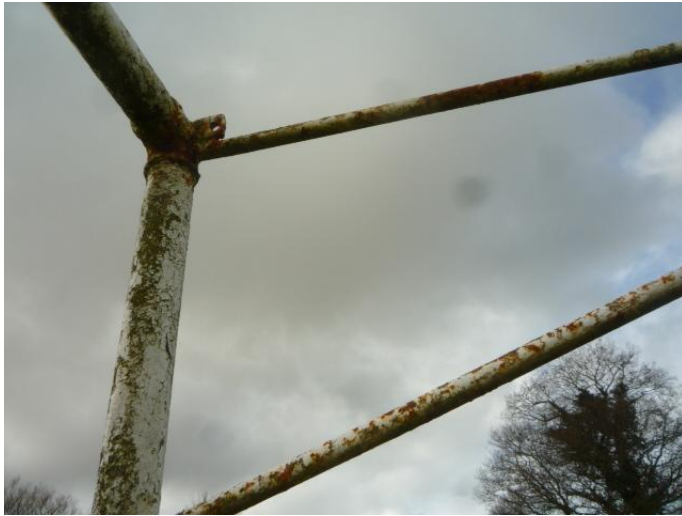
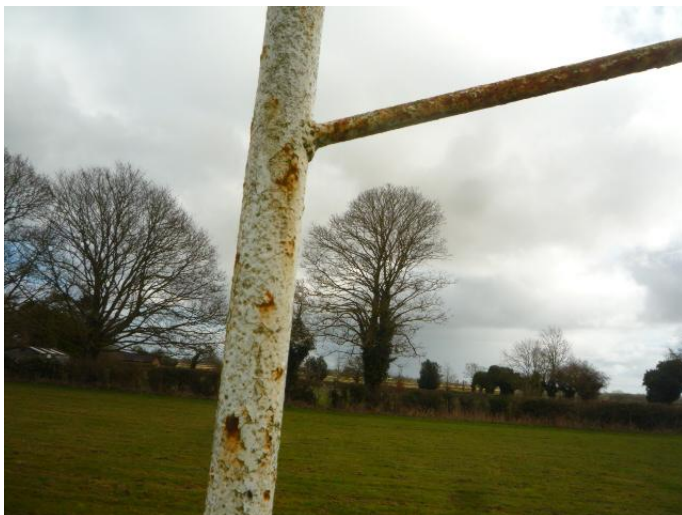
Recommend rub down and remove rust and flaking paint, which has rough and sharp areas - and repaint to prolong life of item - Low risk.

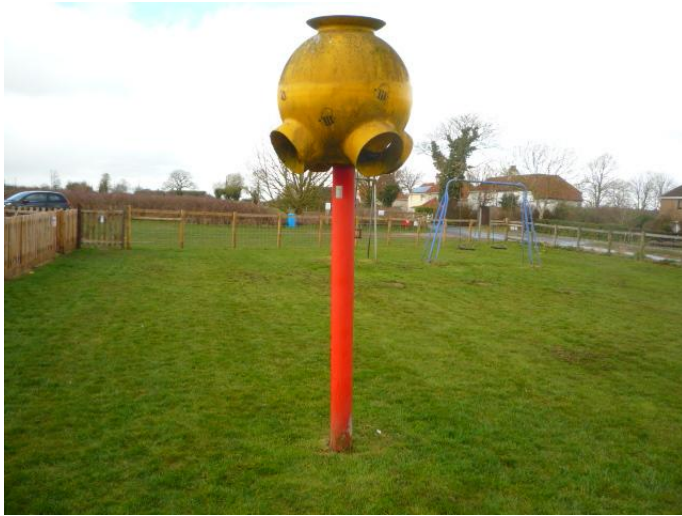
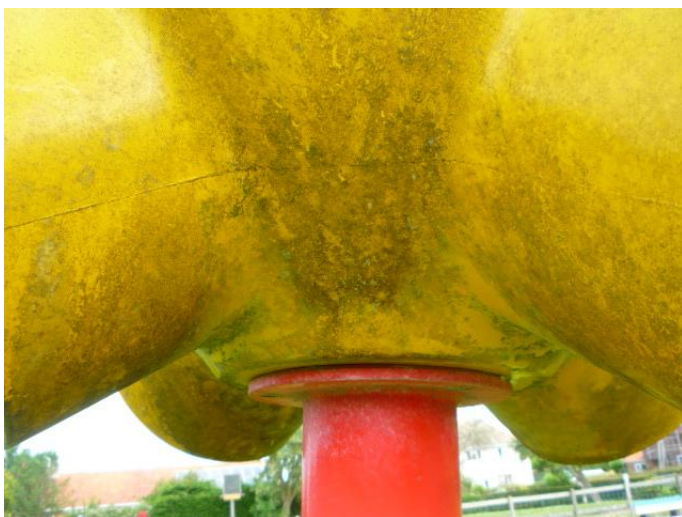
**Item: Ball Shoot (2006-7) – Wicksteed Leisure**

Recommend clean off dirt and algae - Low risk.

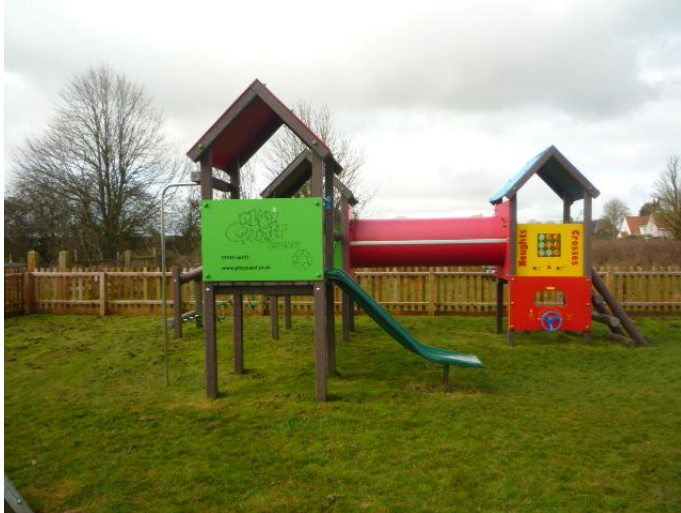
**Item: Multiplay – Play Quest**

The item meets the requirements of EN1176 where this may be tested on site without dismantling or destruction.

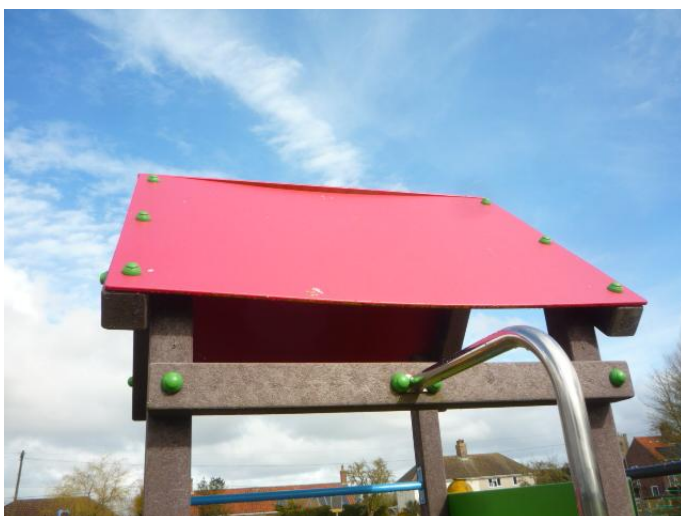
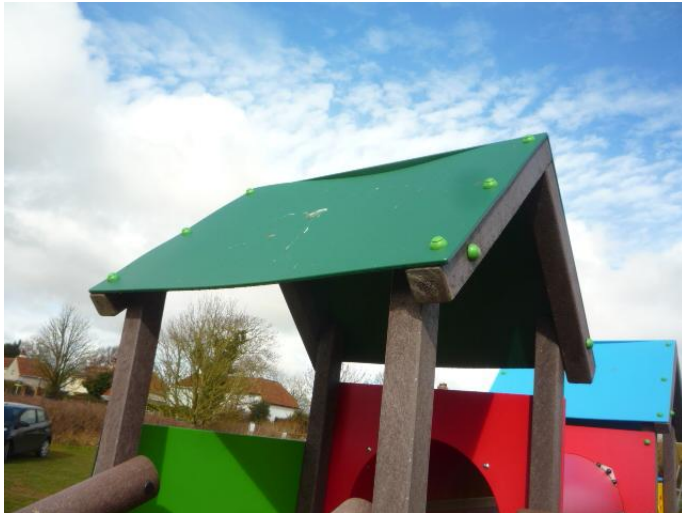
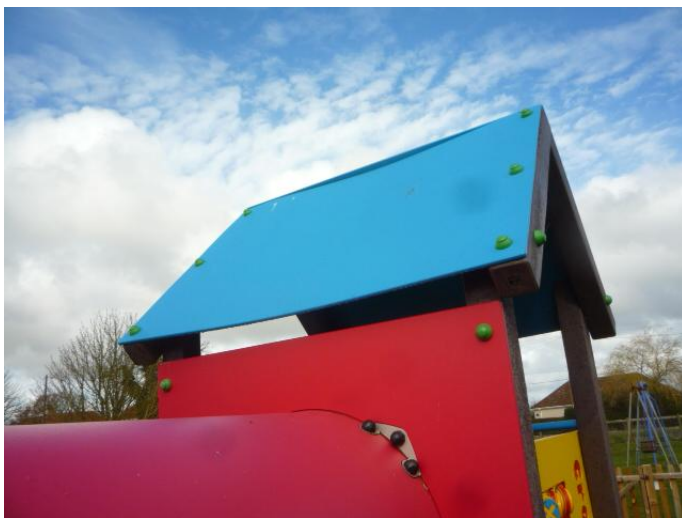
Recommend monitor slight warping of the roof panels - No entrapments were found - Low risk.

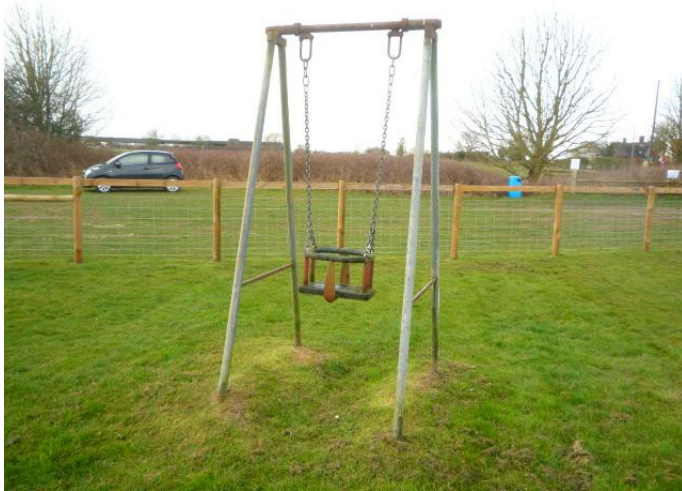
**Item: 1 Bay 1 Cradle Seat Swing (2200mm) – Self Made**

The item fails to meet the requirements of EN1176 in the following respects:

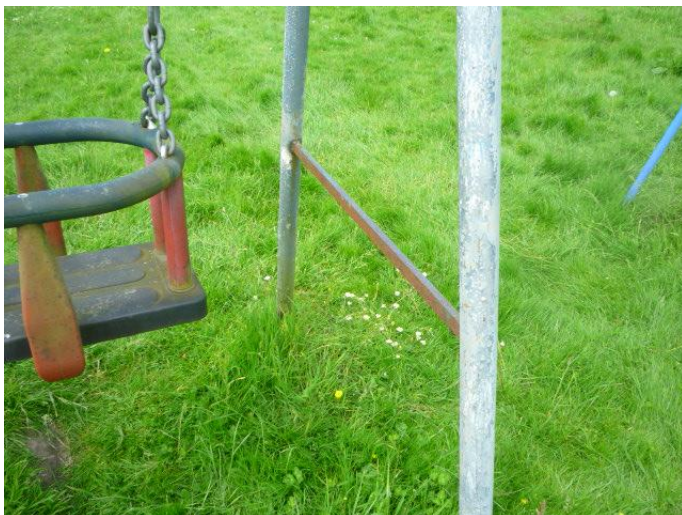
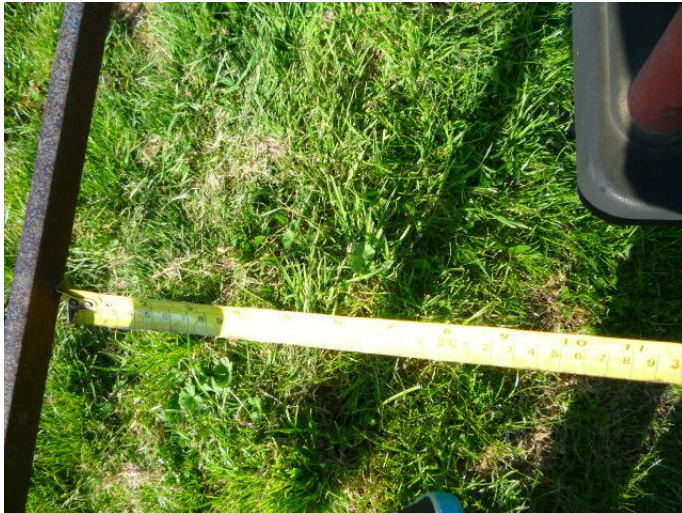
Seat situated too close to supports – Recommend Monitor only – Low risk.

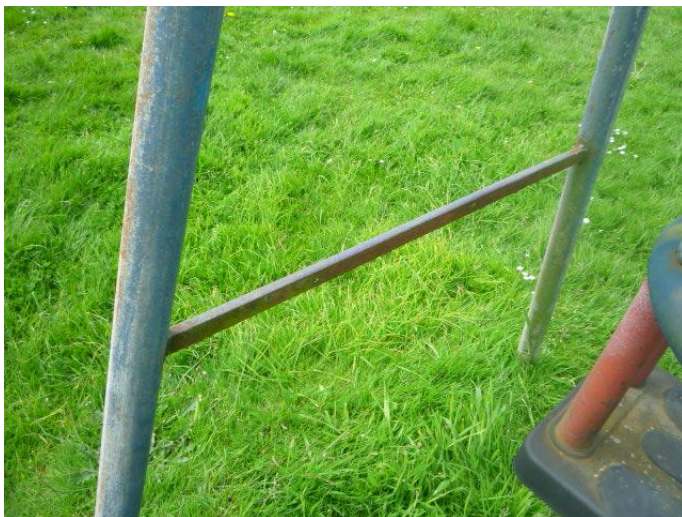
Swing frame bars are climbable – Recommend monitor - Low risk.

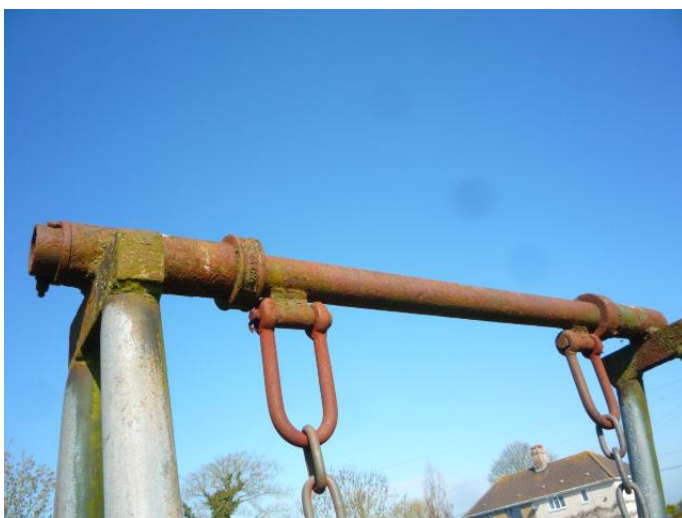
Recommend lubricate shackles at top bar – noisy – Low risk.

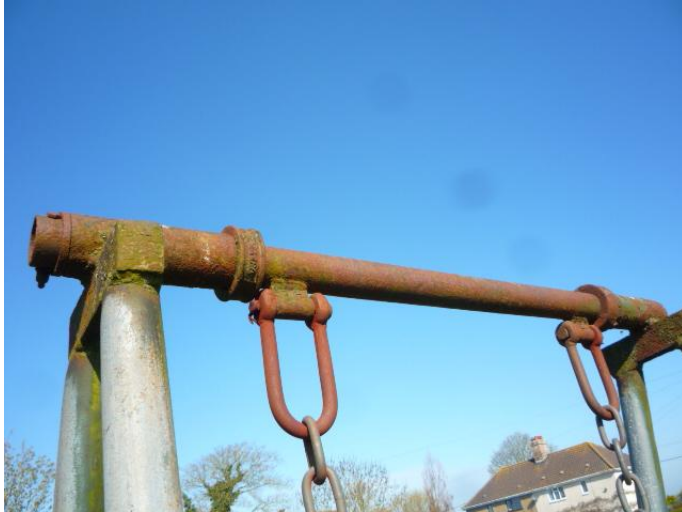
Top Bar - Recommend rub down and remove rust and flaking paint, which has rough and sharp areas - and repaint to prolong life of item - Low risk.

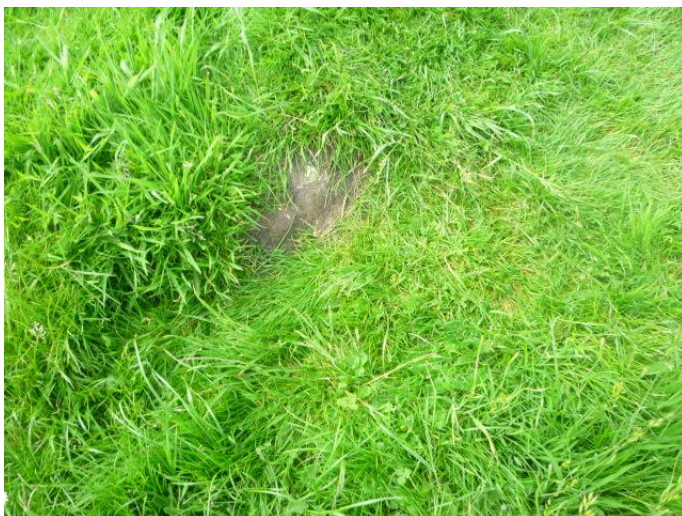
Recommend infill worn and uneven area – Low to Medium risk.

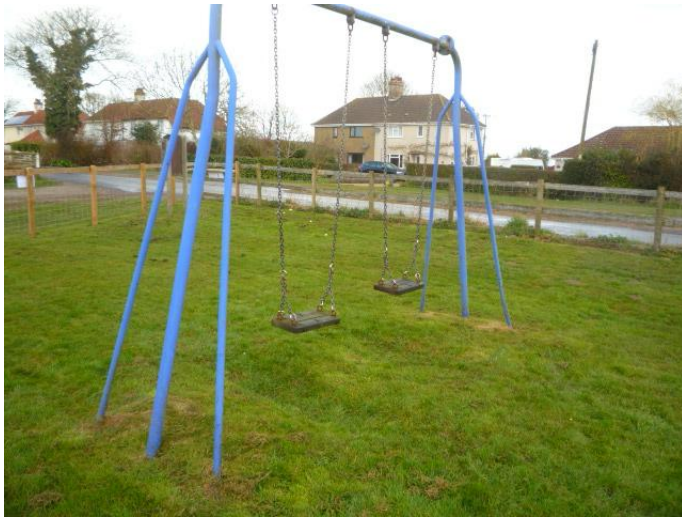
**Item: 1 Bay 2 Flat Seat Swing (2300mm) – Wicksteed Leisure**

The item meets the requirements of EN1176 where this may be tested on site without dismantling or destruction.

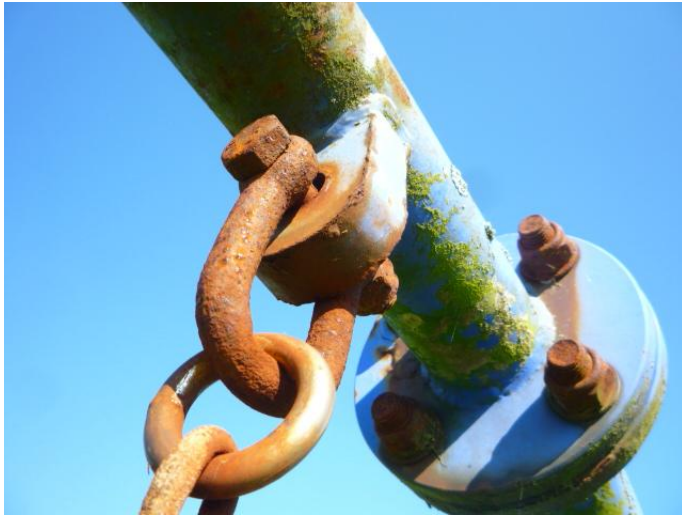
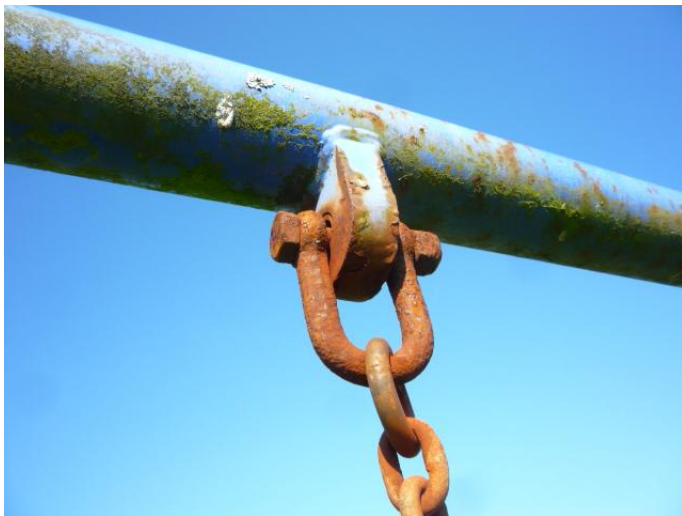
Recommend replace all worn and missing bushes and replace all rusty shackles and bolts at the same time (x 4) – Low risk.

Recommend rub down and remove rust and flaking paint, which has rough and sharp areas - and repaint to prolong life of item - Low risk.

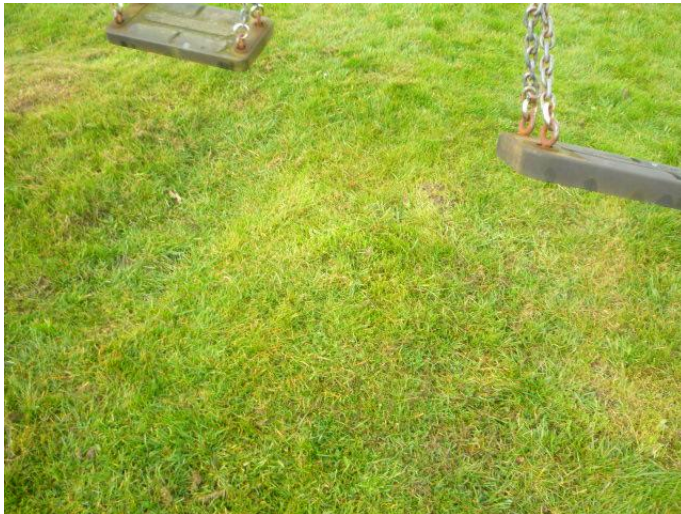
A surface other than grass is required for this item as fall height in in excess of 1500mm - Recommend provide surface to conform to EN1176 – Low to Medium risk.

Recommend infill uneven areas - Low to Medium risk.

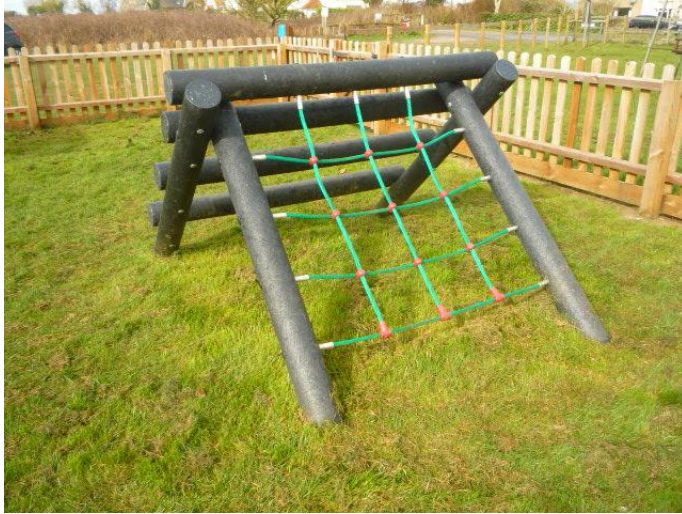
**Item: A Frame Climber – Play Quip**

The item meets the requirements of EN1176 where this may be tested on site without dismantling or destruction.

The surfacing is in a satisfactory condition and no work is required at this time. Continue to inspect and maintain as normal and according to manufacturer’s instructions where provided.

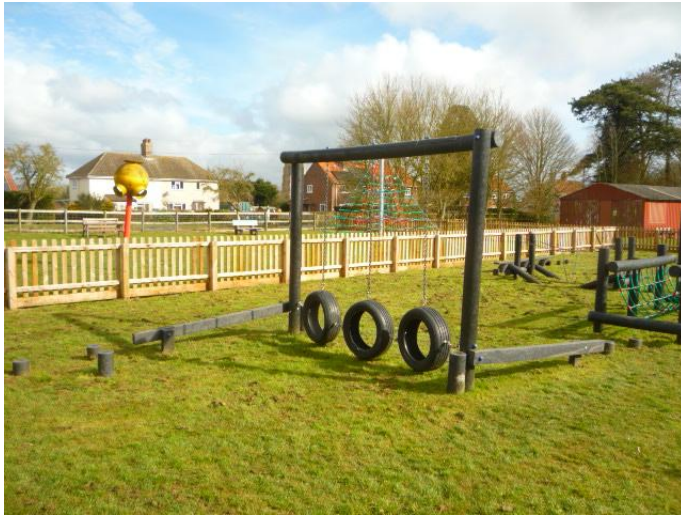
**Item: Beams with Tyre Traverse and Step Posts x 5 – Play Quip**

The item meets the requirements of EN1176 where this may be tested on site without dismantling or destruction.

The surfacing is in a satisfactory condition and no work is required at this time. Continue to inspect and maintain as normal and according to manufacturer's instructions where provided

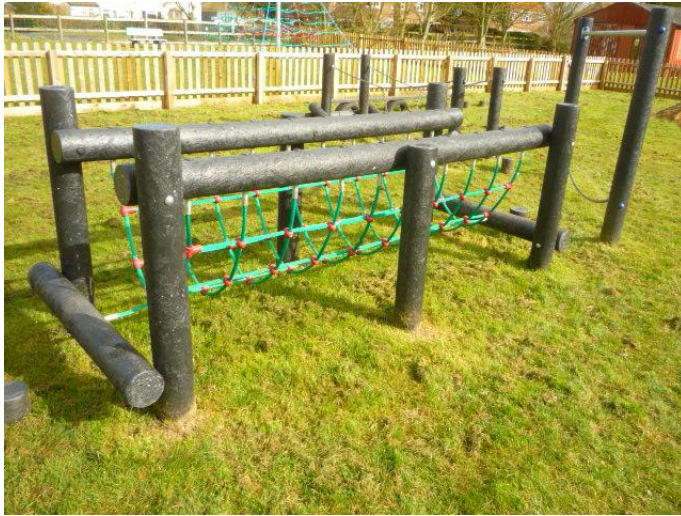
**Item: Rope/Net Bridge with Step Post x 1 – Play Quip**

The item meets the requirements of EN1176 where this may be tested on site without dismantling or destruction.

The surfacing is in a satisfactory condition and no work is required at this time. Continue to inspect and maintain as normal and according to manufacturer's instructions where provided.

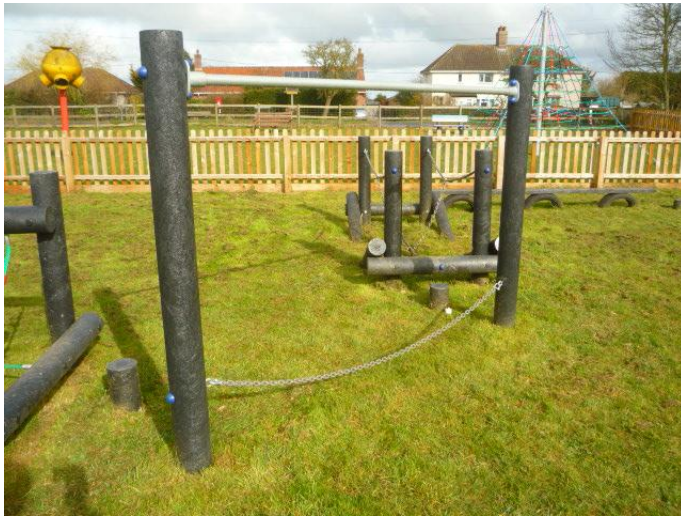
### **Item: Chain Traverse – Play Quip**

The item meets the requirements of EN1176 where this may be tested on site without dismantling or destruction.

The surfacing is in a satisfactory condition and no work is required at this time. Continue to inspect and maintain as normal and according to manufacturer's instructions where provided.

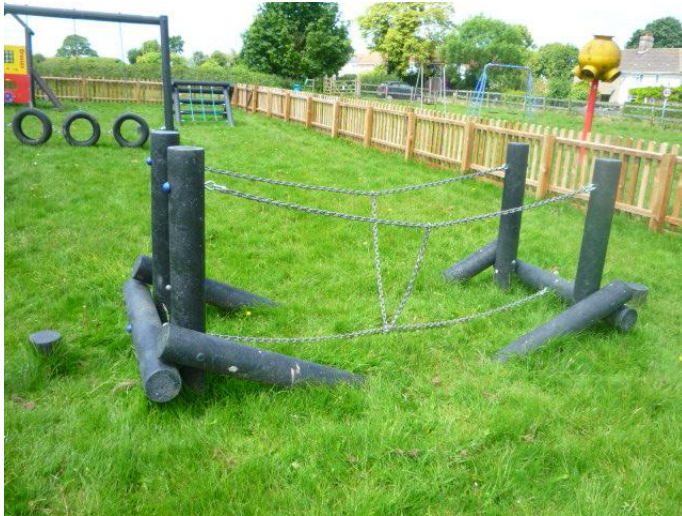
**Item: Burma Bridge with Step Posts x 2 – Play Quip**

The item meets the requirements of EN1176 where this may be tested on site without dismantling or destruction.

The surfacing is in a satisfactory condition and no work is required at this time. Continue to inspect and maintain as normal and according to manufacturer's instructions where provided.

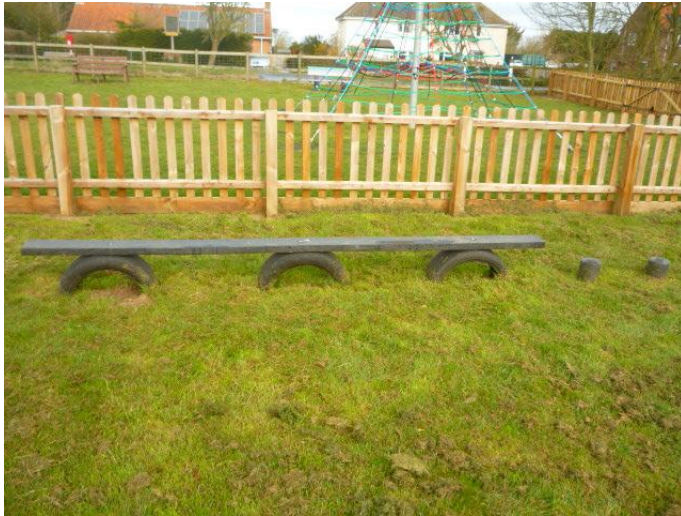
### **Item: Beam on Tyres with Step Posts x 2 – Play Quip**

The item meets the requirements of EN1176 where this may be tested on site without dismantling or destruction.

The surfacing is in a satisfactory condition and no work is required at this time. Continue to inspect and maintain as normal and according to manufacturer's instructions where provided.

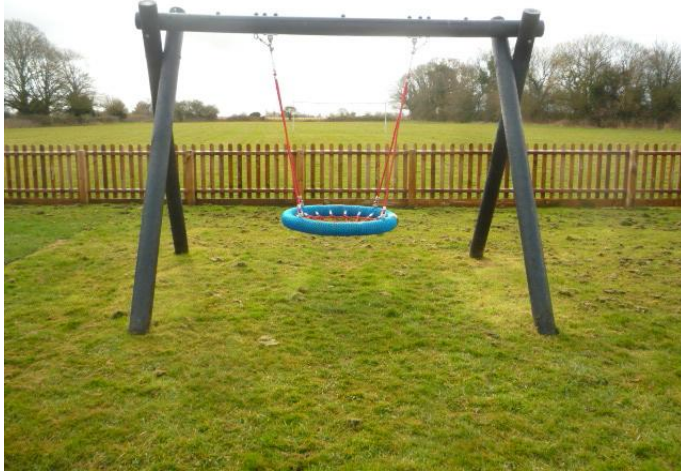
### **Item: Basket Swing (2100mm) – Play Quip**

The item meets the requirements of EN1176 where this may be tested on site without dismantling or destruction.

The surfacing is in a satisfactory condition and no work is required at this time. Continue to inspect and maintain as normal and according to manufacturer's instructions where provided.

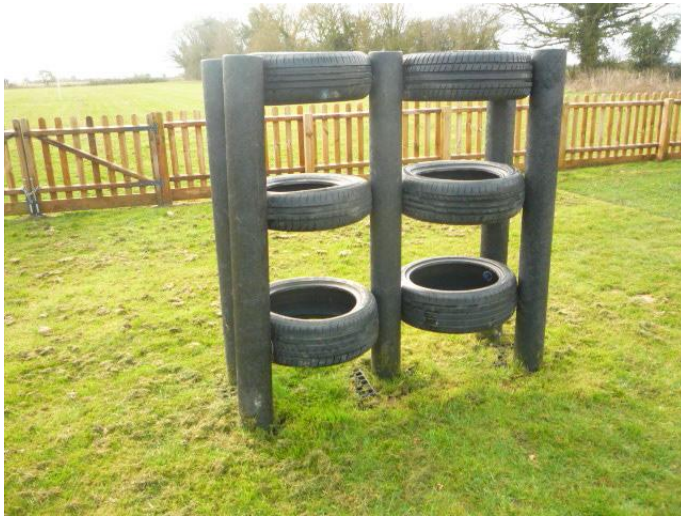
### **Item: Tyre Climber – Play Quip**

The item meets the requirements of EN1176 where this may be tested on site without dismantling or destruction.
